**From:** [Foi Enquiries](#)  
**To:** [REDACTED]  
**Subject:** EIR-17-1524 - Inspection - Esplanade  
**Date:** 14 November 2017 14:44:16  
**Attachments:** [Further Information - Right to Review & Appeal.pdf](#)  
[EIR-17-1524 - Photos.pdf](#)  
[EIR-17-1524 - Map Screenshot.pdf](#)  
[EIR-17-1524 - REPORT Groyne No11 to Groyne No12.pdf](#)  
[EIR-17-1524 - Full page photo.pdf](#)

**We would be grateful if you would provide us with the undernoted information relative to repair, maintenance and inspection of stairs leading from the Esplanade, Aberdeen to the beach opposite the Beach Ballroom.**

## Groyne No11 to Groyne No12

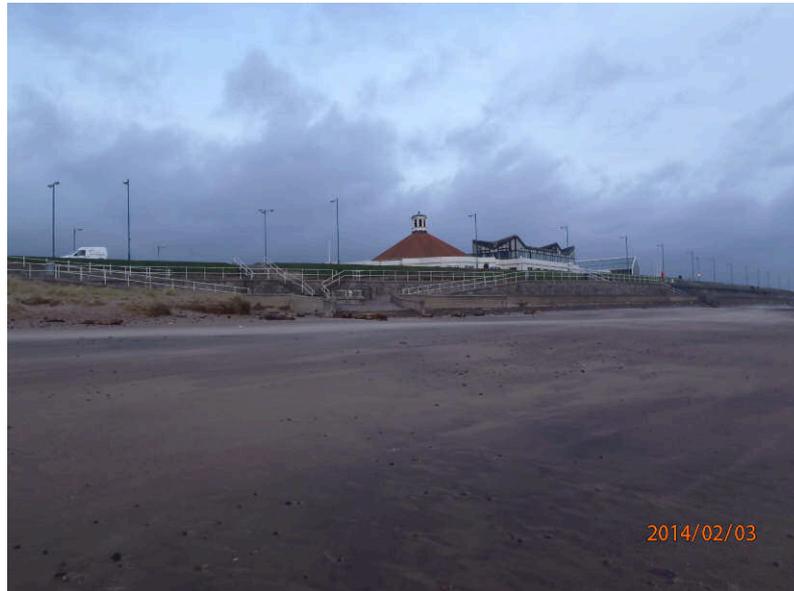
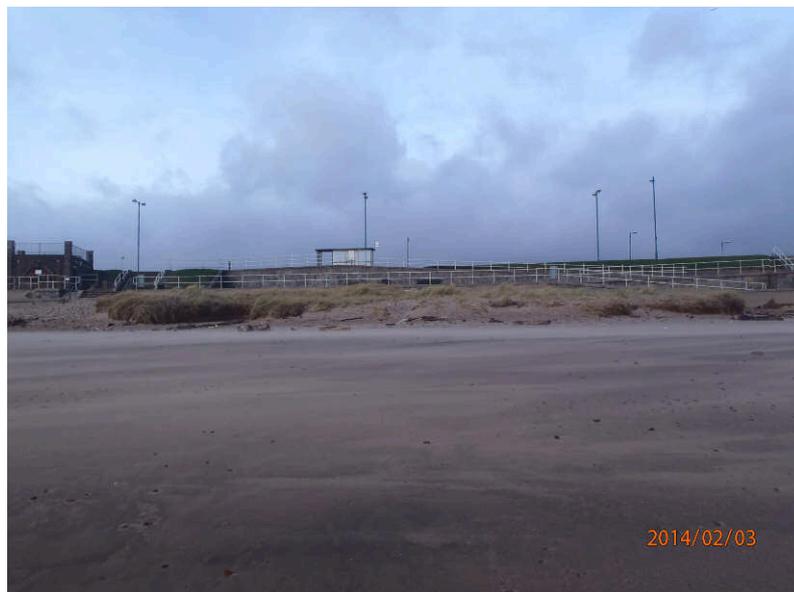
This area of the Sea Wall between Groyne 11 and Groyne 12, is made up of 3 parts due to the amount and the way the sand and driftwood has been driven up the beach and onto the sea wall, the first part between groyne 11 and the steps is totally covered and non of the sea wall is visible.

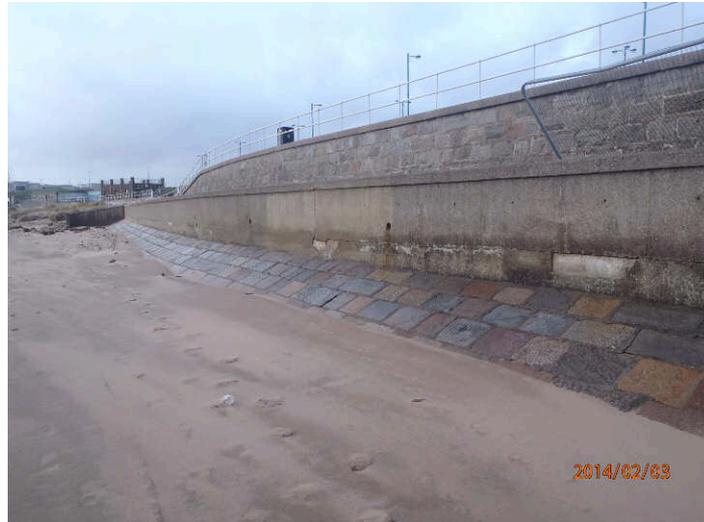
The second part which is the lower part and nearest to the sea is constructed with granite blocks set in concrete. The area of blocks exposed requires pointing in some points.

- Repair the stairs and the cracks in the parapet of the closer stairs of the sea in the main entrance.
- Repointing in some points of the second part of the sea Wall
- The handrails are slightly corroded and they should be repaired.

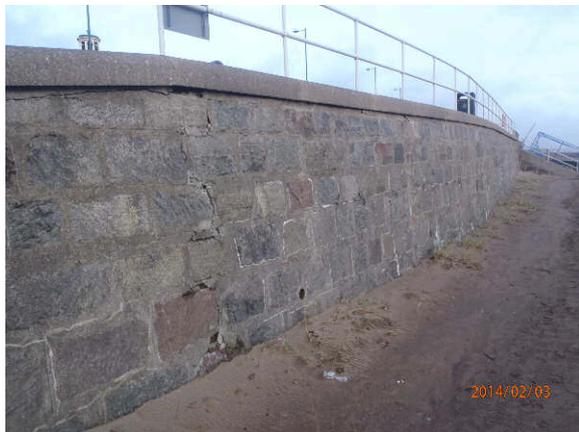
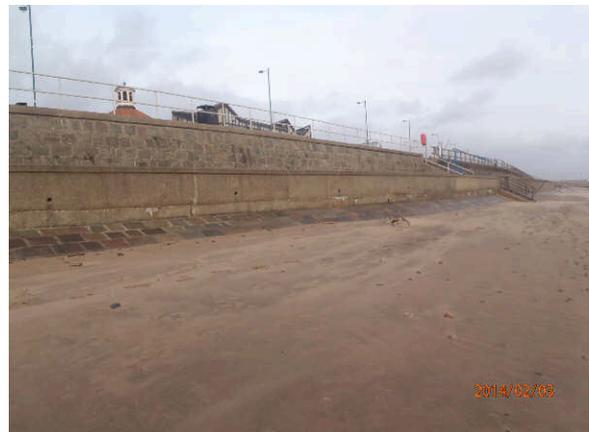
The third part is made up of two walls and a poured concrete footway which has some sand covering it. The wall nearest to the sea presents vertical cracks and carbonation in the down part of the wall.

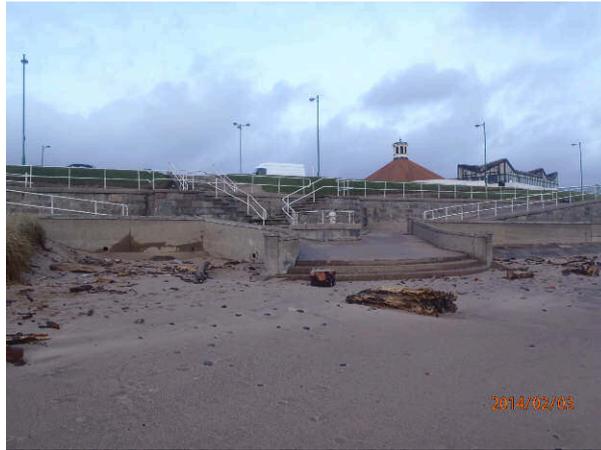
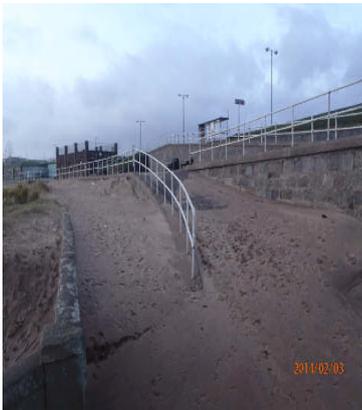
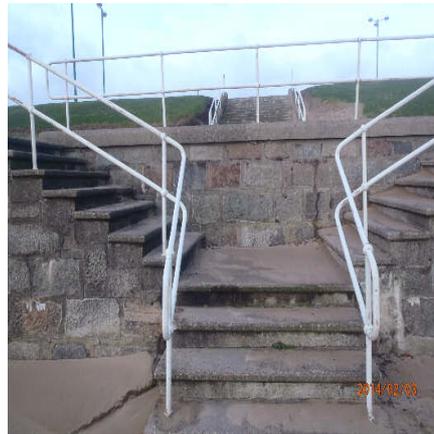
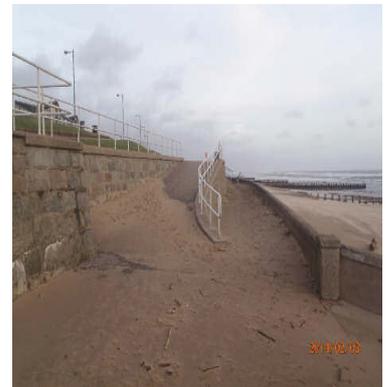
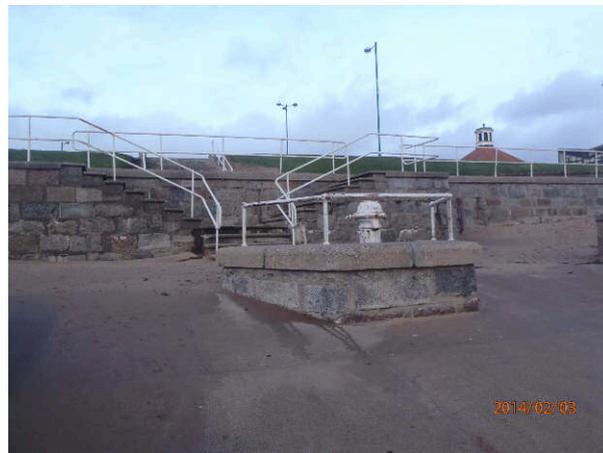
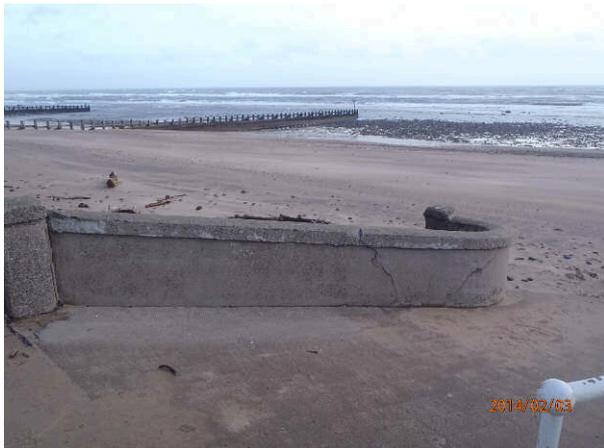
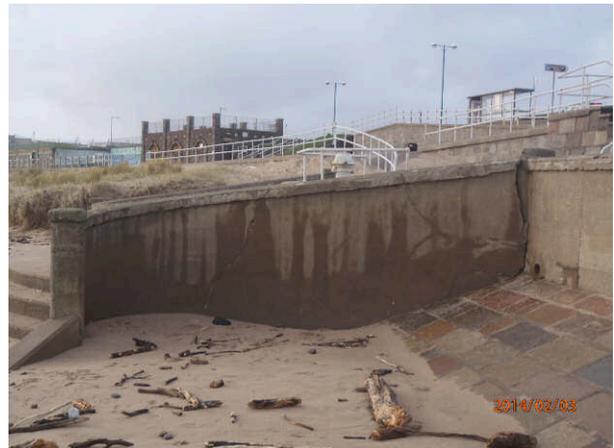
In this part there are two stairs and a main entrance with two ramps and one stairs. The stairs near the groyne 11 was considered in the previous zone. About the main entrance seems to be in good condition in general, only the handrails have a small corrosion problem. In the stairs nearest to the sea one parapet has cracks.

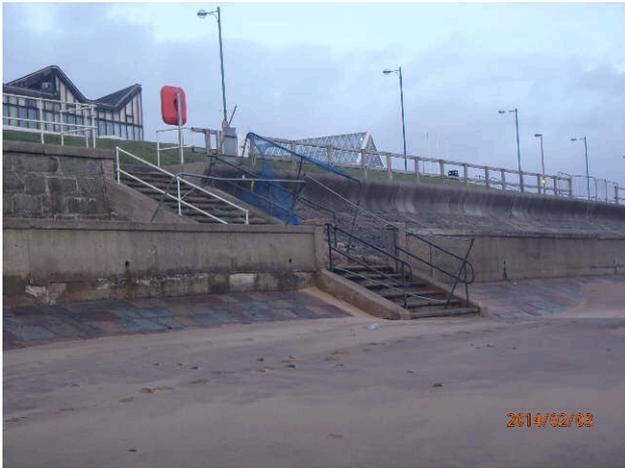
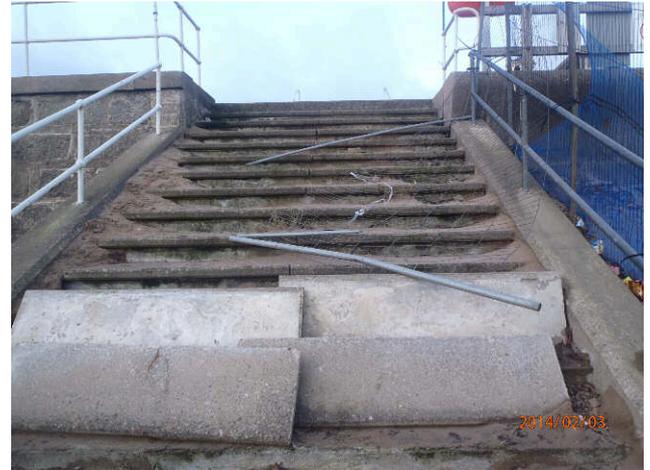
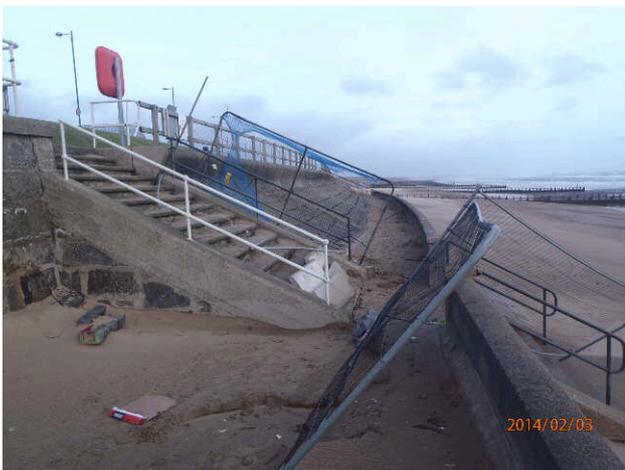
The other stairs is in very bad condition because it has lost the last two steps completely, for that reason have been closed with fence but the water and wind have moved it.

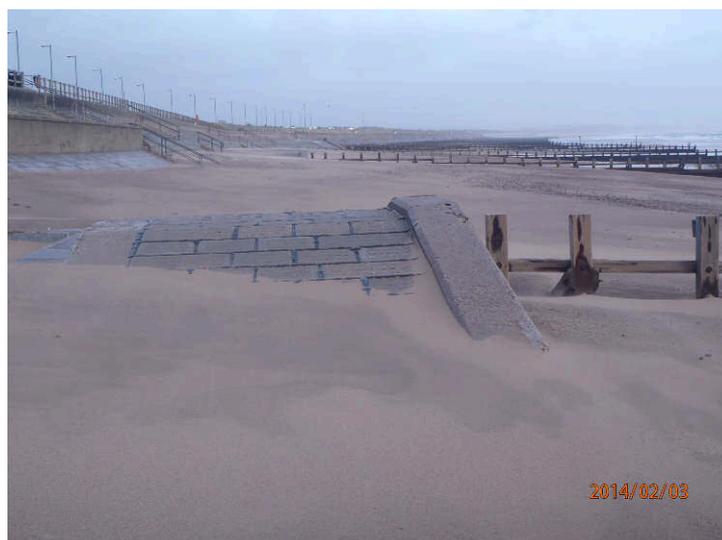
Finally the groyne's ramp is covered partially but in the visible part the ramp presents a little erosion.

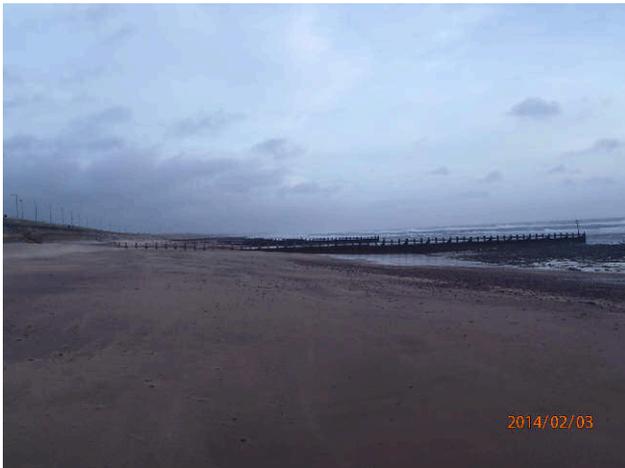
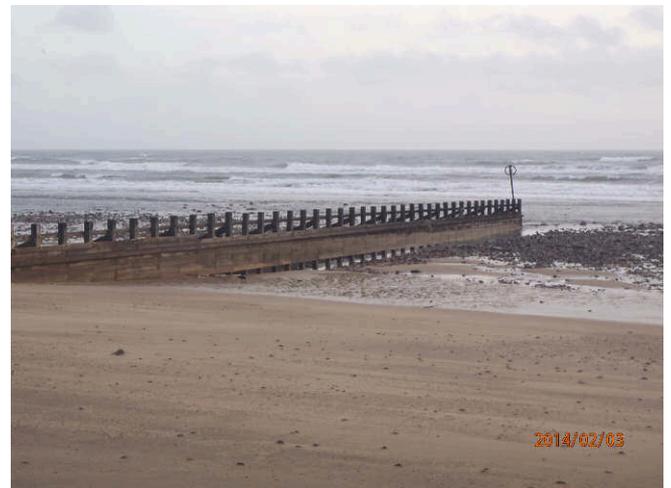
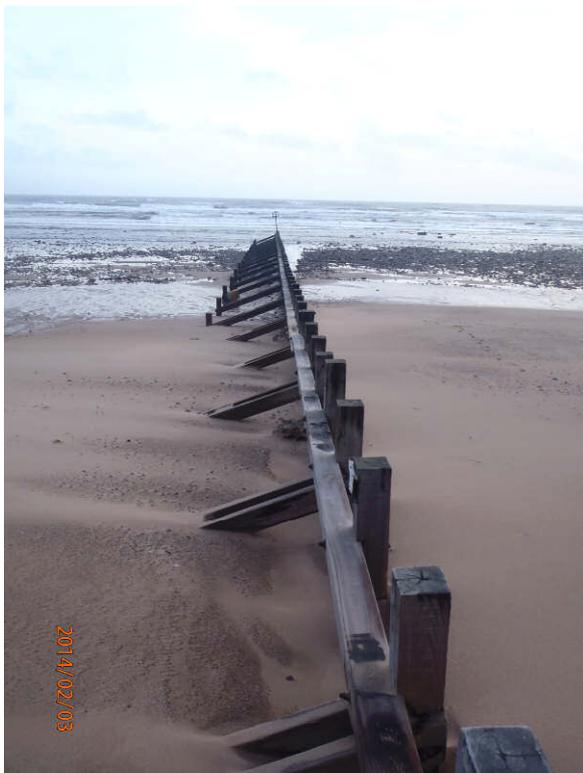
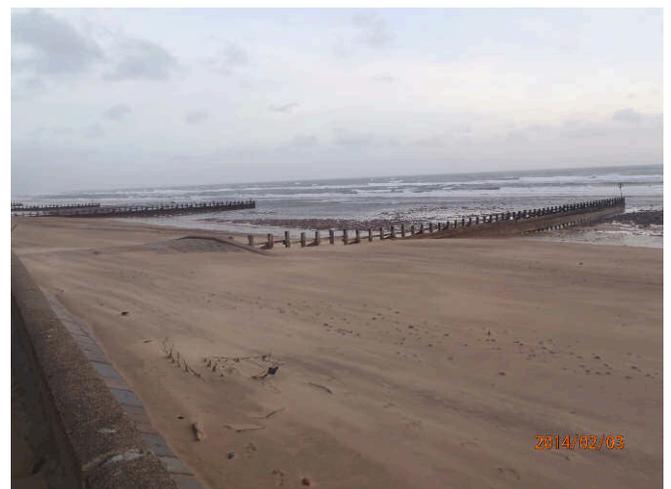
## Groyne 12

This groyne consists of 61 posts at approximately 1.5metre centres with each post being 203mm square. On the north side of the groyne there are 20 stays consisting of 20 posts, 203mm square, each having 2 boards between the posts and the groyne. There are 2 rails running the length of the groyne on either side of the posts measuring 230mm wide by 150mm high and a number of boards fixed to the south side of the posts of variable lengths and 50mm wide and 203mm high. A marker is fixed to the second last most easterly post. The groyne appears to be in good condition.
