5.	Site Details	
5.1	What name would you like the site to be known by? (Please note if the site is currently included within the ALDP2017 please use the OP site number)	Rigifa Farm Area 3, Cove
5.2	Site Address	Land to south of Cove Road Cove Aberdeen
5.3		
5.4	Have you any information for the site on the internet? If so please provide the web address:	Yes / No Details: No
5.5	Is the site currently being marketed?	Yes / No Details: No
5.6	Site Location Map (Please include an OS Map with the Boundary of the site clearly marked)	Details:
5.7	Please provide the National Grid reference of the site.	NJ940002
5.8	What is the current use of the site?	Open fields
5.9	Has there been any previous development on the site? If yes please provide details	Yes / No Details:

RIGIFA FARM COVE, ABERDEEN

124028: Residential Development - Rigifa

DEVELOPMENT BID FOR SITE AT RIGIFA FARM, COVE LANDSCAPE APPRAISAL on behalf of Mactaggart & Mickel

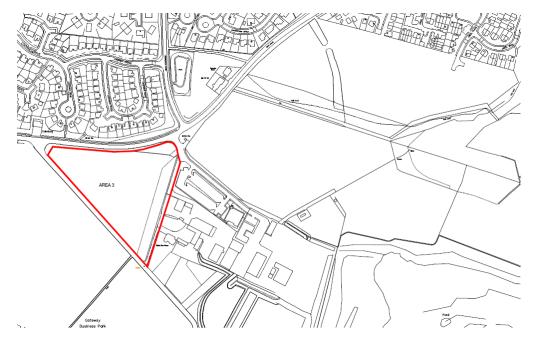
The site (Area 3) is located to the south-east of Cove, to the south of Cove Road. It extends to approximately 2.2 ha (5.4 acres) and is bounded to the north by Cove Road beyond which lies existing residential development; to the east Rigifa Farm and Leiths Quarry; to the south and west by an unclassified Road leading to the Quarry and Findon further south and land being developed at Aberdeen Gateway Business Park. The site is identified outlined and red on the map below.

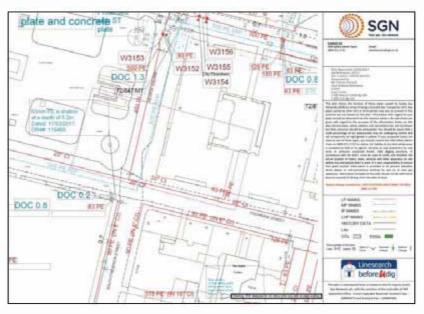
Example of a gas map

Note: Service pipes are not shown on our maps

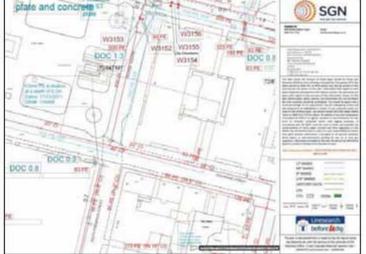
< Your gas service pipe usually takes the shortest route to the gas main, as shown on the sample network map/drawing.

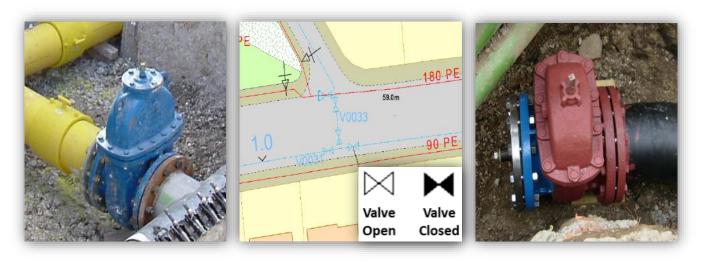
The images below are an illustration of typical gas valves. Please note, valves come in various colours, shapes and sizes, and you may come across a valve that looks different to those found in the images.

Due to a manufacturing issue, we are currently replacing or upgrading certain valve types that are at risk of bolt failure. In extreme cases, this can lead to gas escapes. This is a safety hazard and we have produced this guide to ensure you undertake adequate safety precautions when working near gas valves.

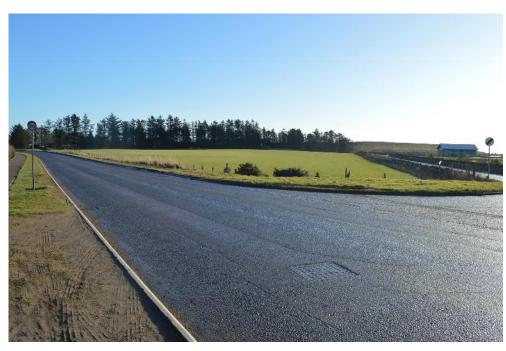
Area 3 open to view and to the elements on two sides

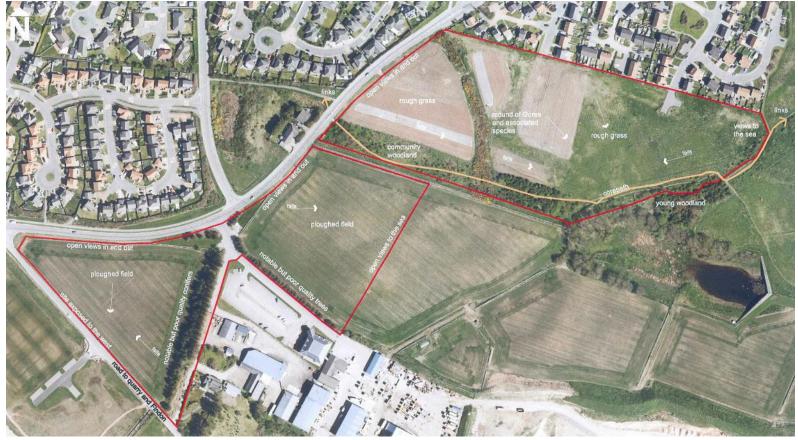
2.0 site location plan

- site surrounded on 3 sides by residential and commercial development
- gently sloping ground presenting no difficulty for housing development
- bundaries of stone dykes and fences containing shelterbelts and visual screen planting that with some degree of enhancement could visually absorb new development
- site is a destination and hub for a well developed footpath network through Cove, including corepath 78, the coastal path northwards from Cove
- the surrounding residential properties are both visually connected and at the same time exposed to the site

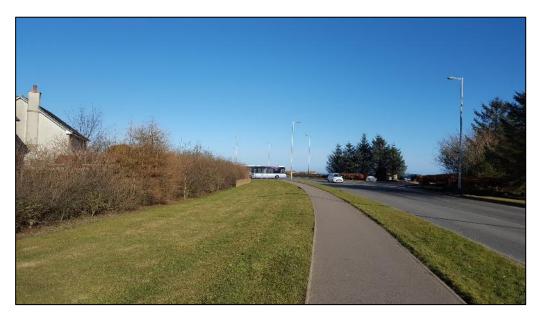
2.3 There is a footway on the northern side of Cove Road as it passes the proposed allocation site. This footway provides a link to existing residential areas served to the north of Cove Road. There is a footway on the southern side of Cove Road, but its western extent is at the western edge of the existing houses served by Creel Road immediately to the east of the proposed allocation site.

Footway on northern side of Cove Road

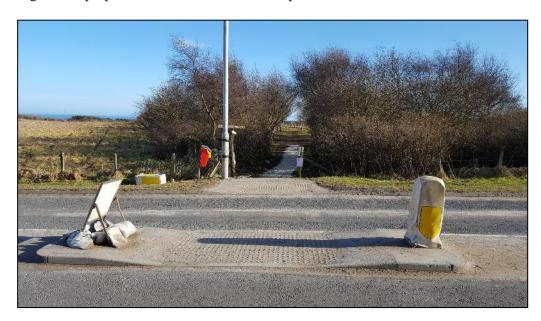
Core Path 78 to south of Cove Road

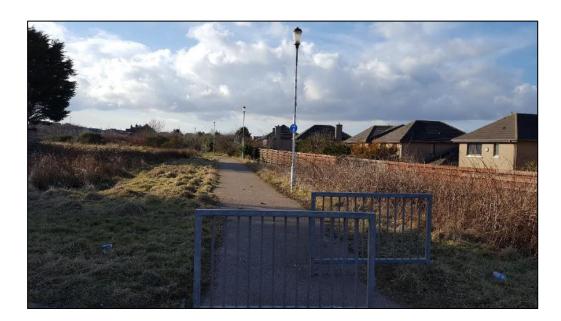
Shared-use path north of Cove Road

- A shared-use pedestrian and cycle path runs from the road forming the western boundary of the proposed allocation site westwards to the Aberdeen Gateway business park to the west. This path starts on the opposite side of the road from the southwestern corner of the proposed allocation site and emerges on Gateway Drive at the eastern edge of the business park. It would be around a three-minute walk from the southwestern corner of the proposed allocation site to the business park using this route.

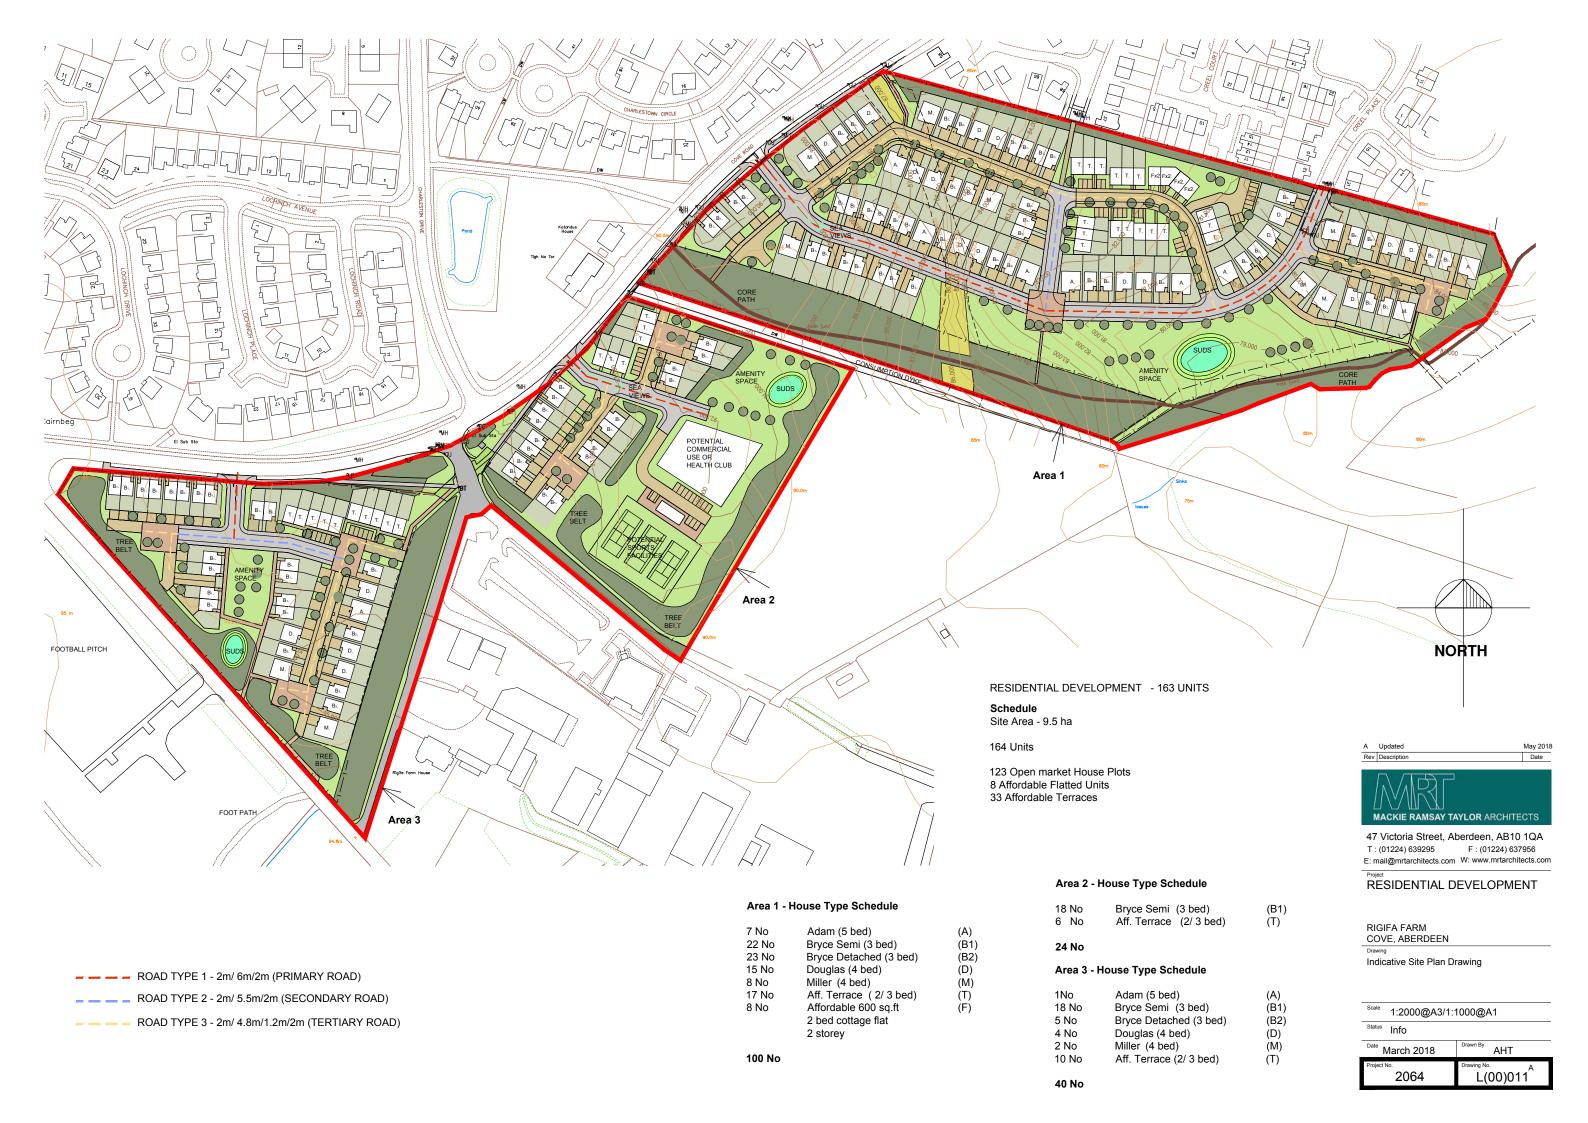
- 2.9 ACC and Aberdeen Cycle Forum produce maps showing cycle routes in the city and a copy of the map for the area around the proposed allocation site is provided in Appendix B. The map shows the route of NCN Route 1 in the area and also recommended cycle routes, such as the segregated path leading from Cove Road (around 380m east of the norther edge of the proposed allocation site) and emerging on Langdykes Road, from where paths lead to the Altens industrial area.
